Journal of Environment and Sustainability

RESEARCH PAPER

Anthropogenic influences on morphological changes in the Progo River, Daerah Istimewa Yogyakarta Province, Indonesia

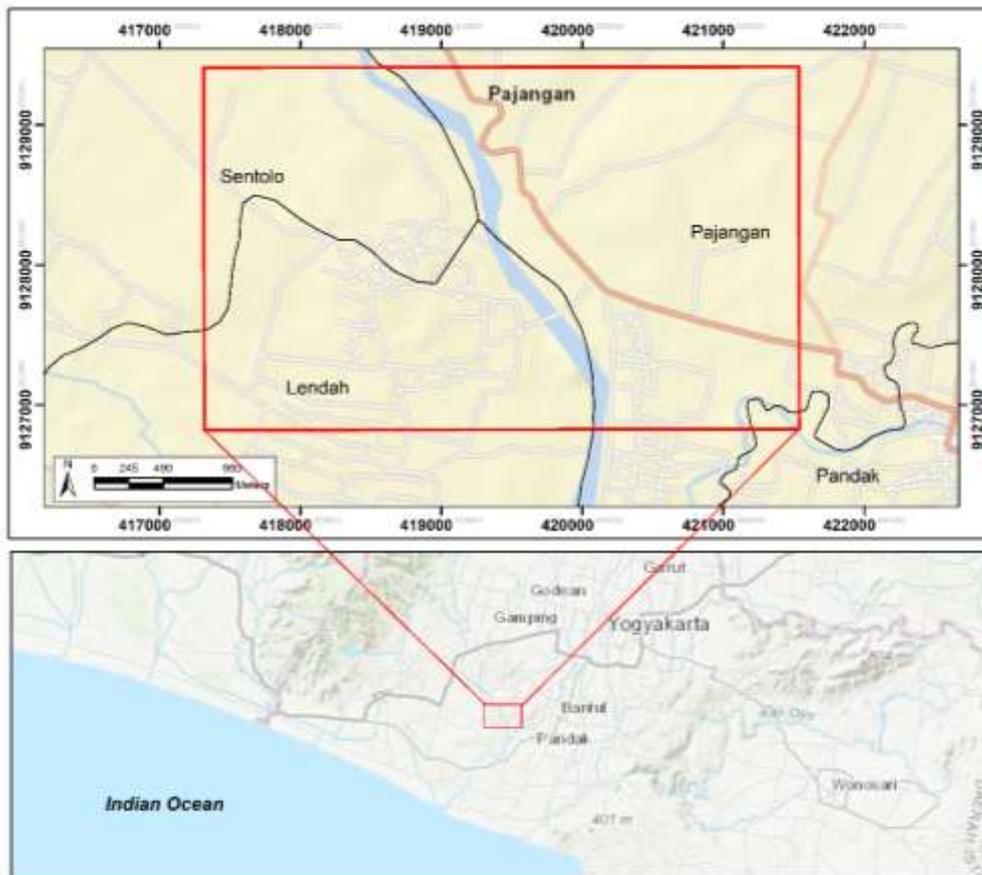
Figure 1. The study area.

The study area is located in Bantul Regency, Daerah Istimewa Yogyakarta Province, Java Island, Indonesia (Figure 1). The size of the Progo River watershed is around 17,432 square kilometers. Many building structures are along the Progo River, such as bridge, revetment, irrigation intake, weir, and ground sill. The Progo River has several tributaries located in Mount Merapi. In addition, the irrigation water of the Kulon Progo Regency and Sleman Regency is taken from the Progo River (Harsanto, 2015; Fitriadin et al., 2017). The study area is focused on the middle-downstream site of the Progo River with a length of around 2.24 kilometers.

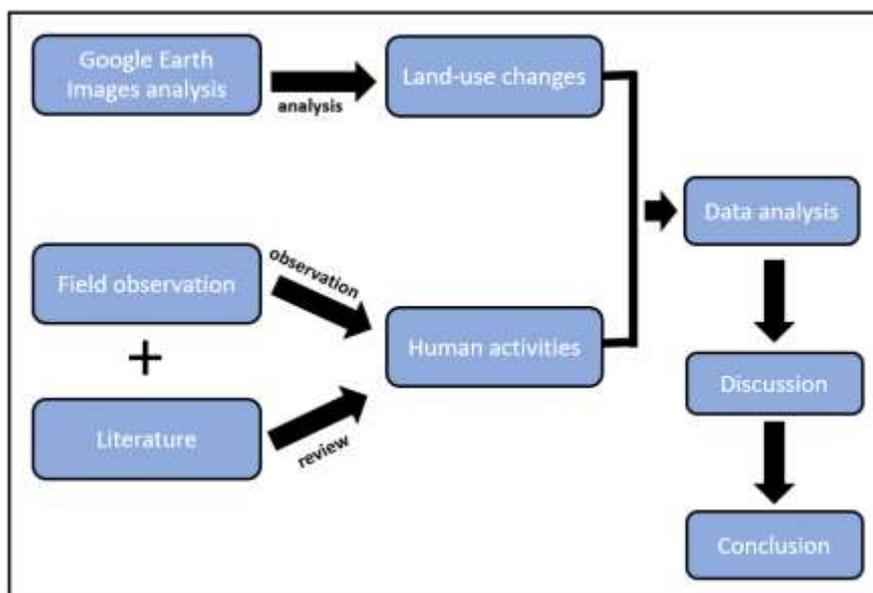
Figure 2. The flowchart methodology.

The stages in this study are Google Earth Images analysis, field observations, data analysis, discussions, and conclusions. The first stage in this study is Google Earth Images analysis. It is carried out by analyzing the morphological changes of the Progo River from 2012 to 2019. The research is focused on observing changes in the points along the Progo River, including the conditions of land-use changes that occur around the Progo River. The second stage is the field observation. The observation is about human activities that were estimated as the causes of morphological changes in the Progo River. Some human activities found along the Progo River include sand mining and garbage piling along the riverbanks. The next stage is data analysis. Data analysis was conducted by comparing data of Google Earth Images and data of field observations. In addition, information about human activities that have occurred along the Progo River from the literature was also carried out to support data analysis. Based on the data

analysis, a discussion of the results is carried out to answer this study's purposes. The last step is to make a study conclusion. The flowchart methodology is shown in Figure 2.

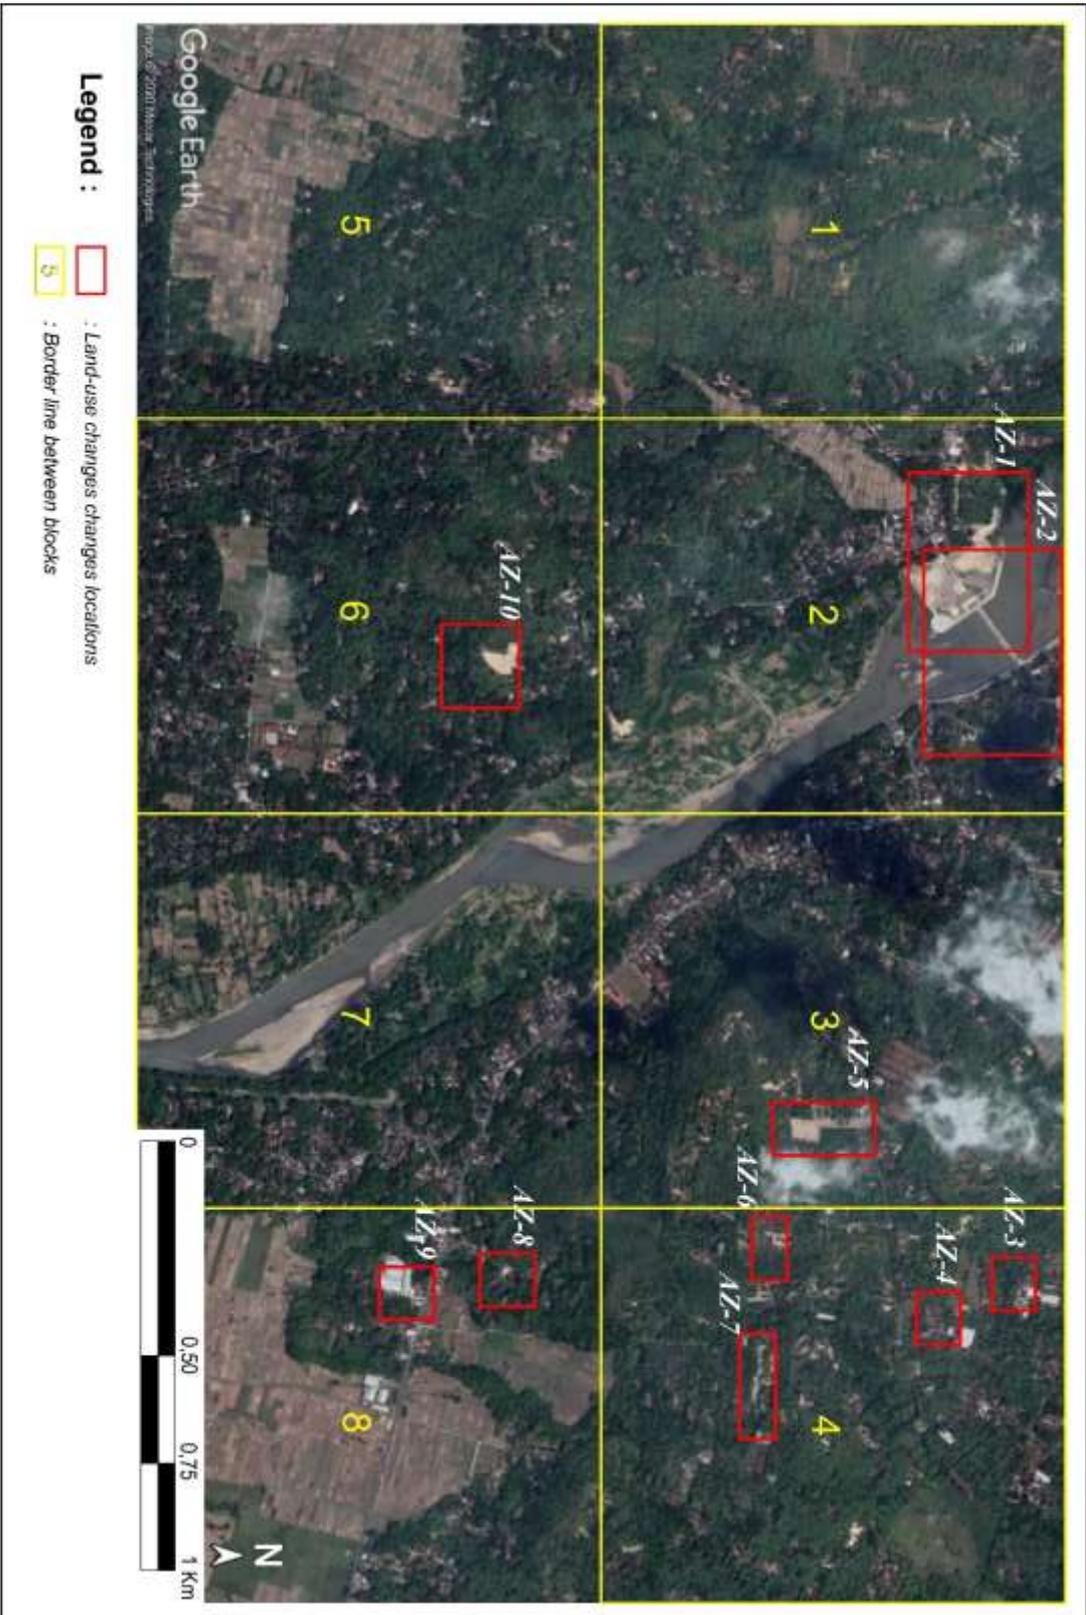
Figure 3. The land-use changes locations on the Progo River and the surrounding area in 2019 (Google Earth Image).

Land-use changes that occur around the Progo River are expected due to the opening of agricultural land, settlement areas, industrial areas, and the construction of the Kamijoro Dam. Figure 3. shows locations on the Google Earth Image that have land-use changes from 2012 to 2019. The observation on each block has been created so that the authors have determined ten locations that have occurred land-use changes (Figure 3). Each location was coded AZ-1 to AZ-10. To clarify each location of land-use changes from 2012 to 2019, it enlarges each red box (Figure 4, 5, 6, and 7).

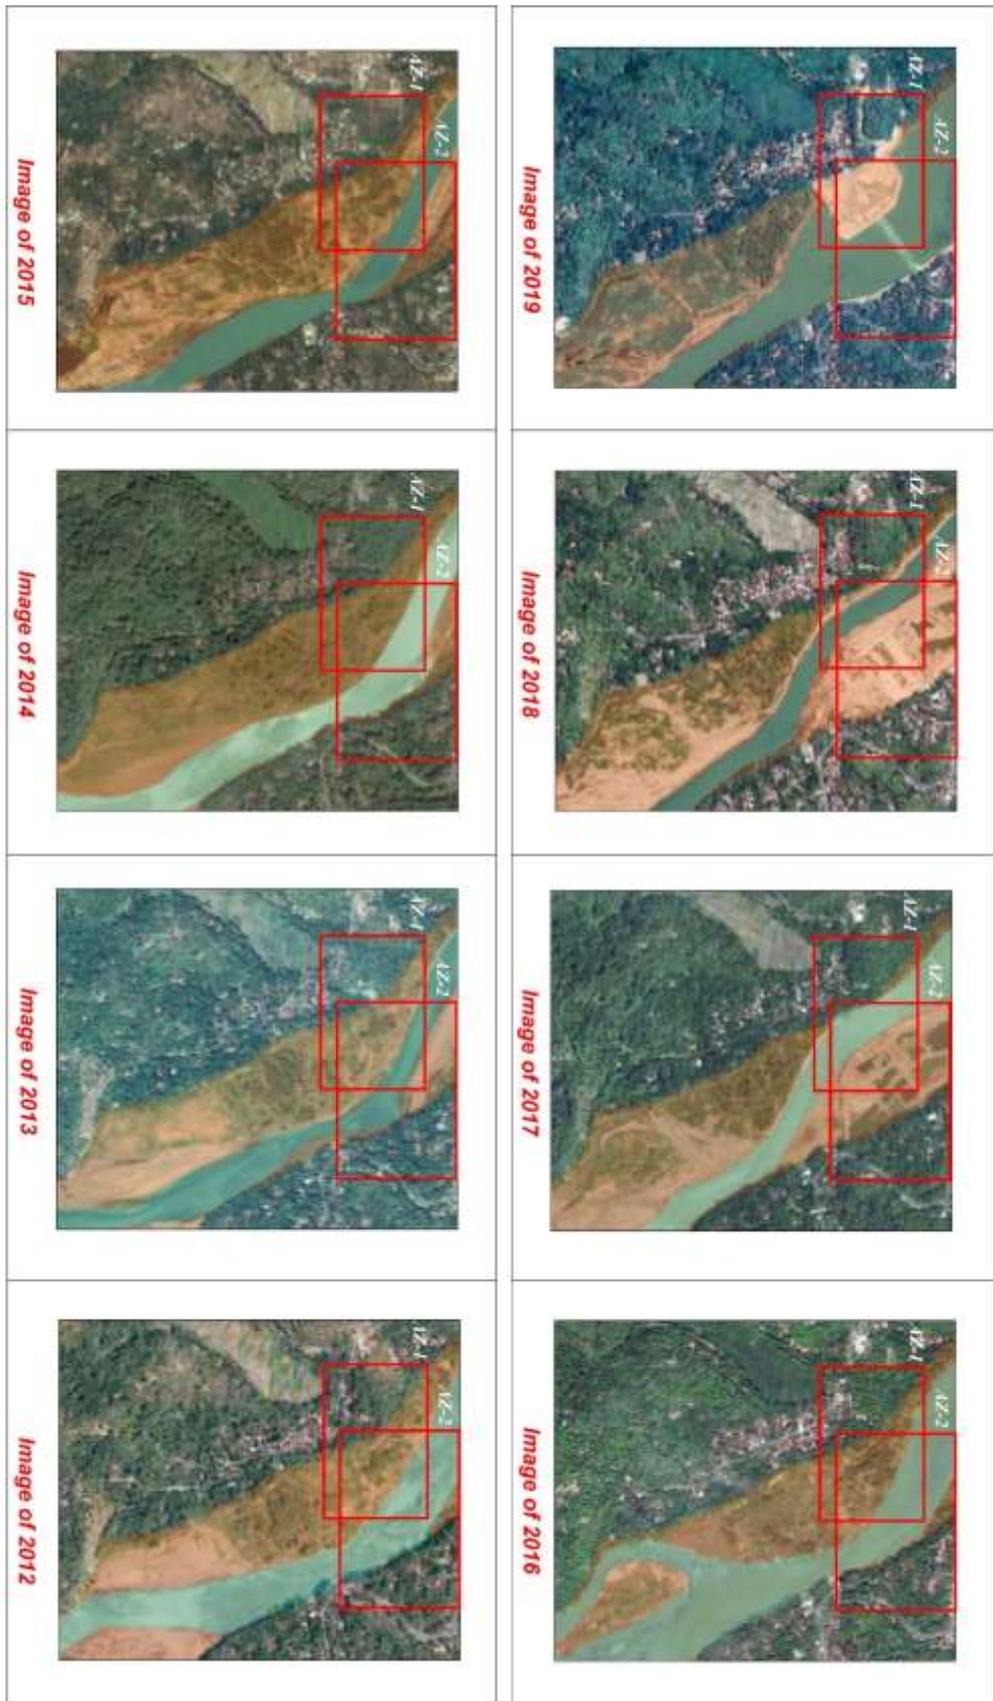
Figure 4. Morphological changes at locations of AZ-1 and AZ-2 from 2012 to 2019.

According to Figure 4, the largest land-use change was estimated to begin in 2016 at the start of the Kamijoro Dam construction. Some sediment deposits were reduced in 2016. Based on Google Earth Image of 2017, it shows sediment dredging activities to shift the streamflow to the west so that the initial dam construction can be built on the river's east side. This is supported by Google Earth Image of 2018, which shows that the dam was built in the east by building its primary construction. In 2019, the structure of the Kamijoro Dam had been finished. Figure 5 shows that in the locations of AZ-3 to AZ-7 occurred land-use changes starting in 2015, this is estimated due to the opening of agricultural land (AZ-5 and AZ-7) and settlement areas (AZ-3, AZ-4, and AZ-6) in that location. According to Figure 6. and Figure 7, they show that in the locations of AZ-8 to AZ-10 occurred land-use changes starting in 2015, which is estimated due to the opening of agricultural land in that location.

Land-use changes due to dam construction had an effect on sediment supply downstream of the dam. Figure 4. shows the sediment deposited downstream of the dam in 2017 was starting to decrease. It was estimated that sediment crushing when the dam was being constructed, or sediment supply decreased because it was deposited at the dam. In addition, land-use changes around the Progo River due to the opening of agricultural land and settlement areas had an effect on decreasing the infiltration area, so that the number of trees holding the soil from erosion was reduced, producing more eroded sediment that flowed to the river. These sediments could flow and be deposited in the river, affecting the increase in sediment supply in the river, and it causes river siltation. There are an additional 637 ha of open land and 7,142 ha of plantations around the Progo River. Open land around the Progo River is used for agricultural land, industrial areas, and settlement areas. It causes an increase in erosion, thereby increasing the sediment supply to the Progo River (Rezagama et al., 2019). Still, the data about the relation between the sediment deposited and the opening of agricultural land and settlement areas in this study could not be correlated in detail, so further periodical research is needed.

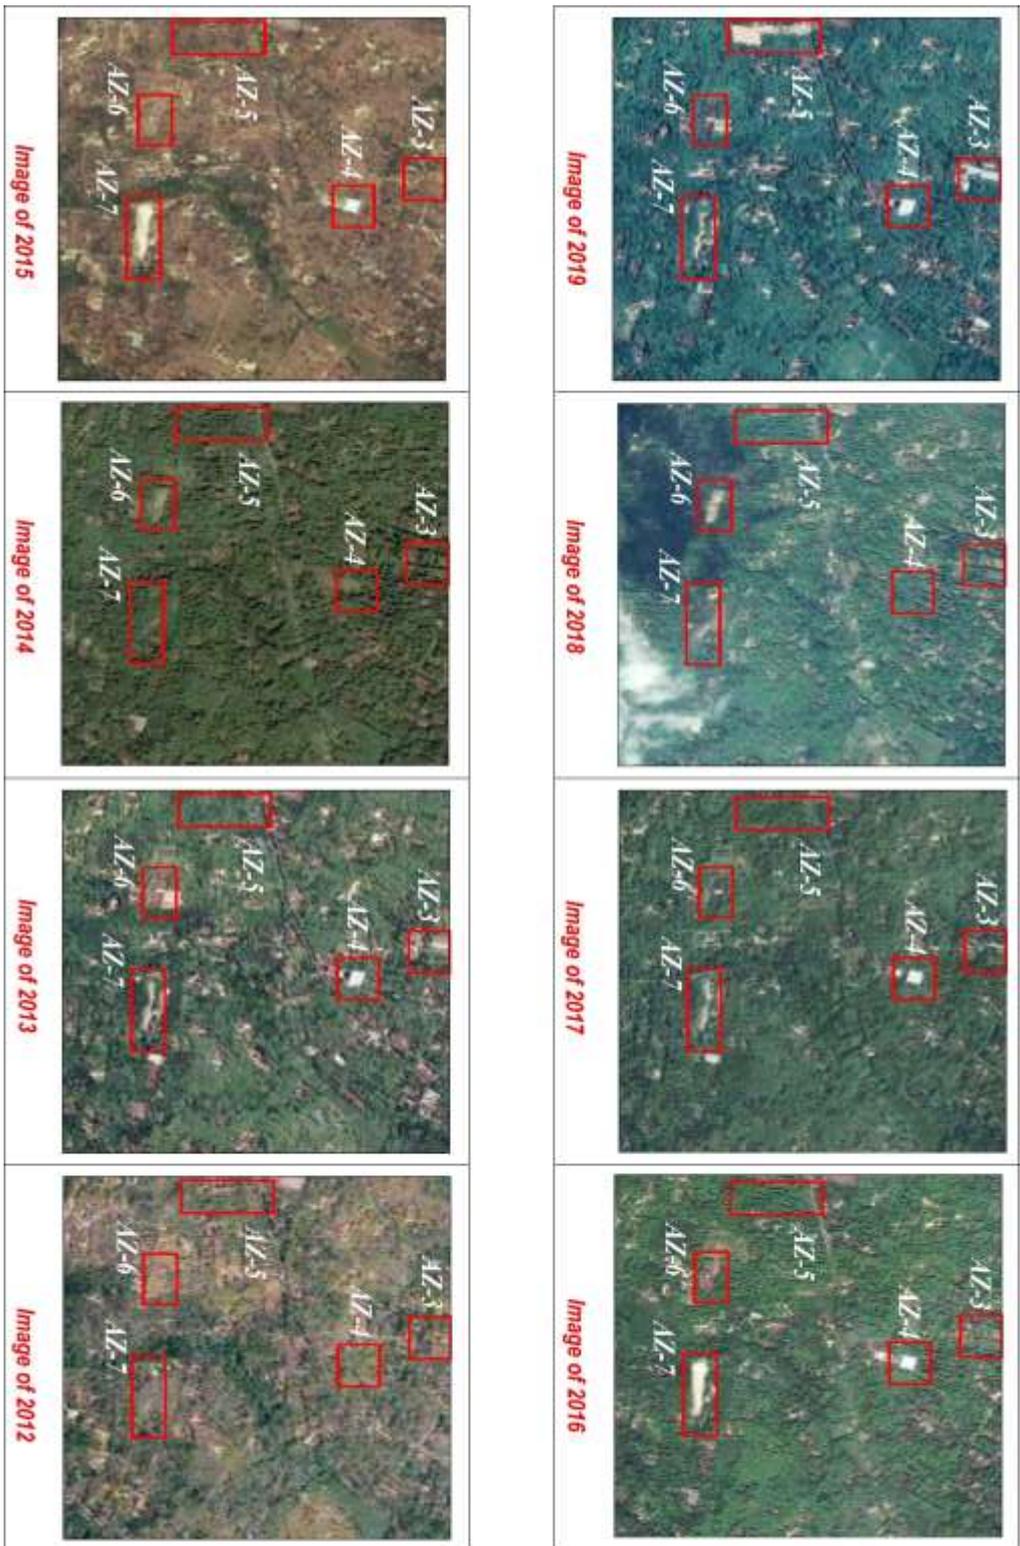
Figure 5. Morphological changes at locations of AZ-3 to AZ-7 from 2012 to 2019.

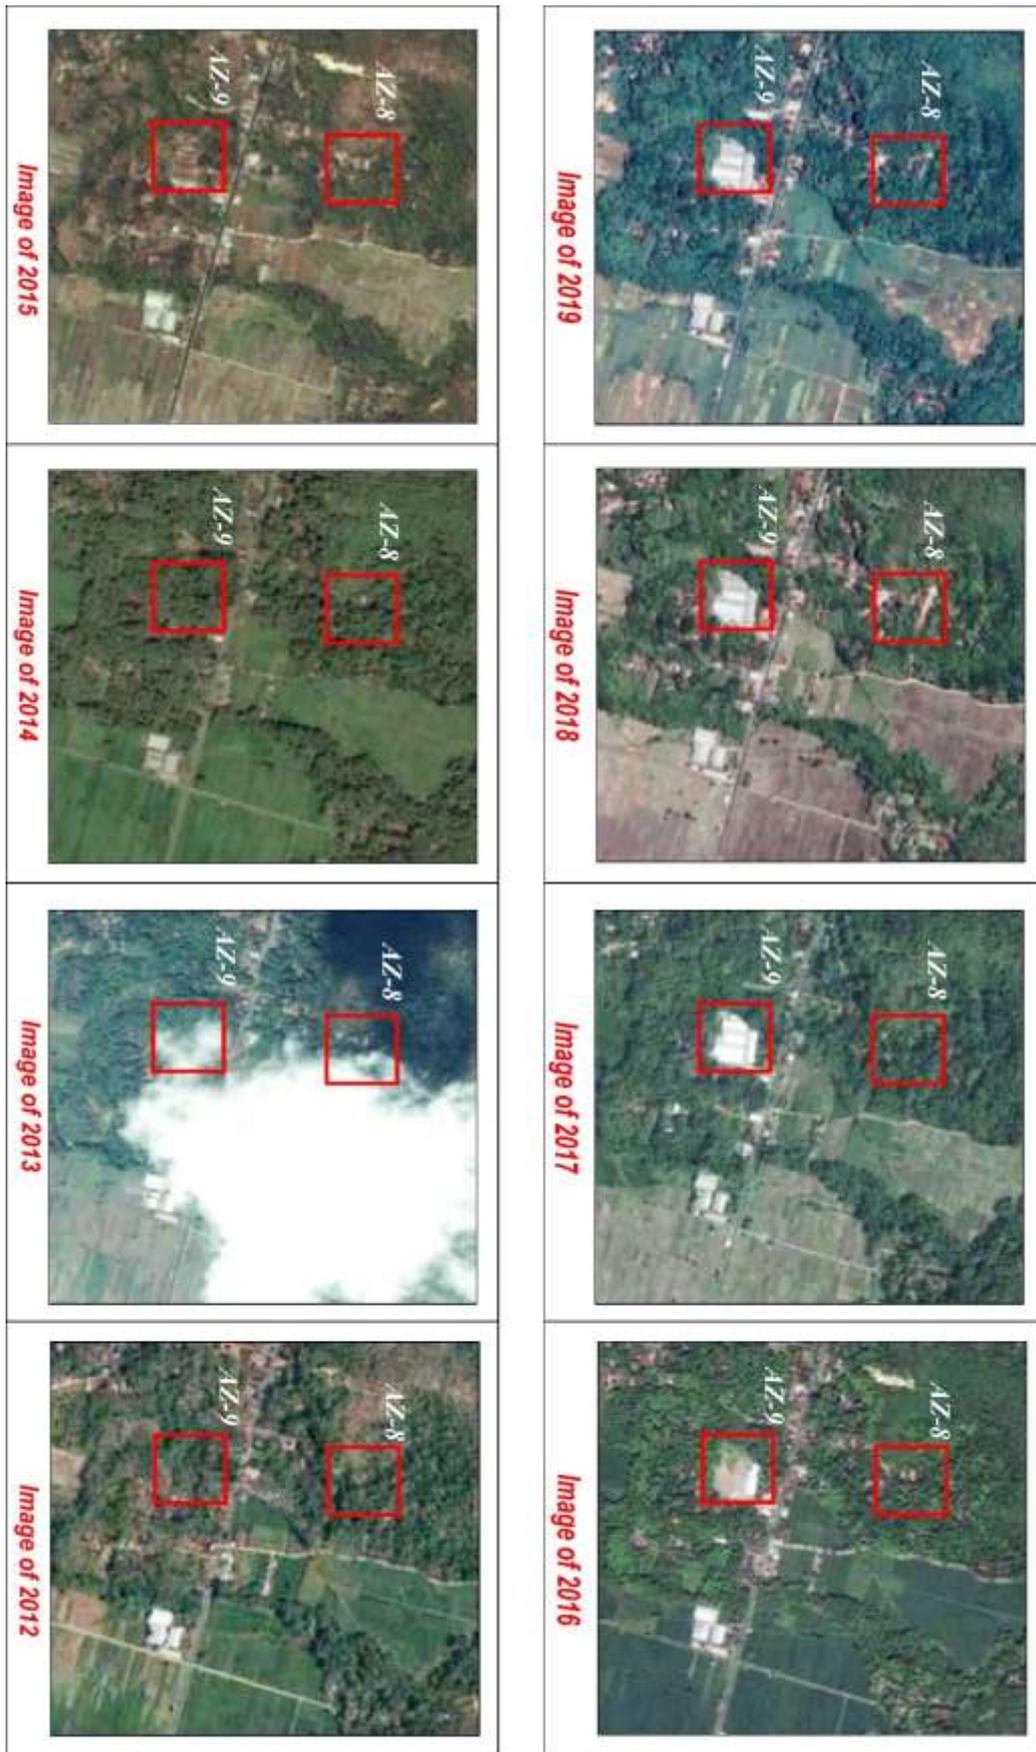
Figure 6. Morphological changes at locations of AZ-8 and AZ-9 from 2012 to 2019.

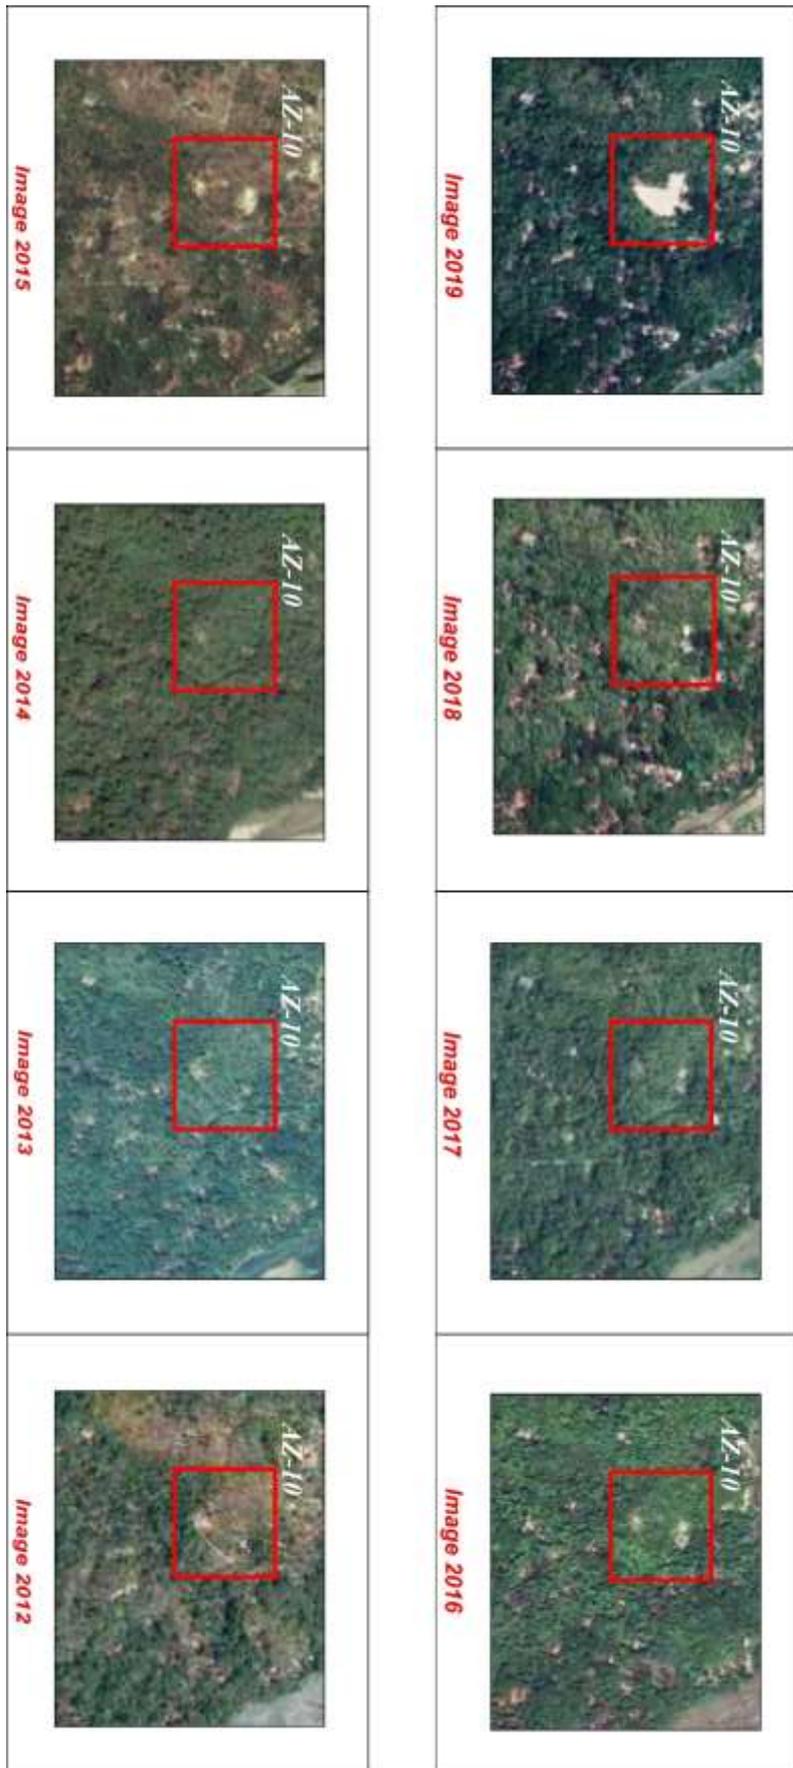
Figure 7. Morphological changes at locations of AZ-10 from 2012 to 2019.

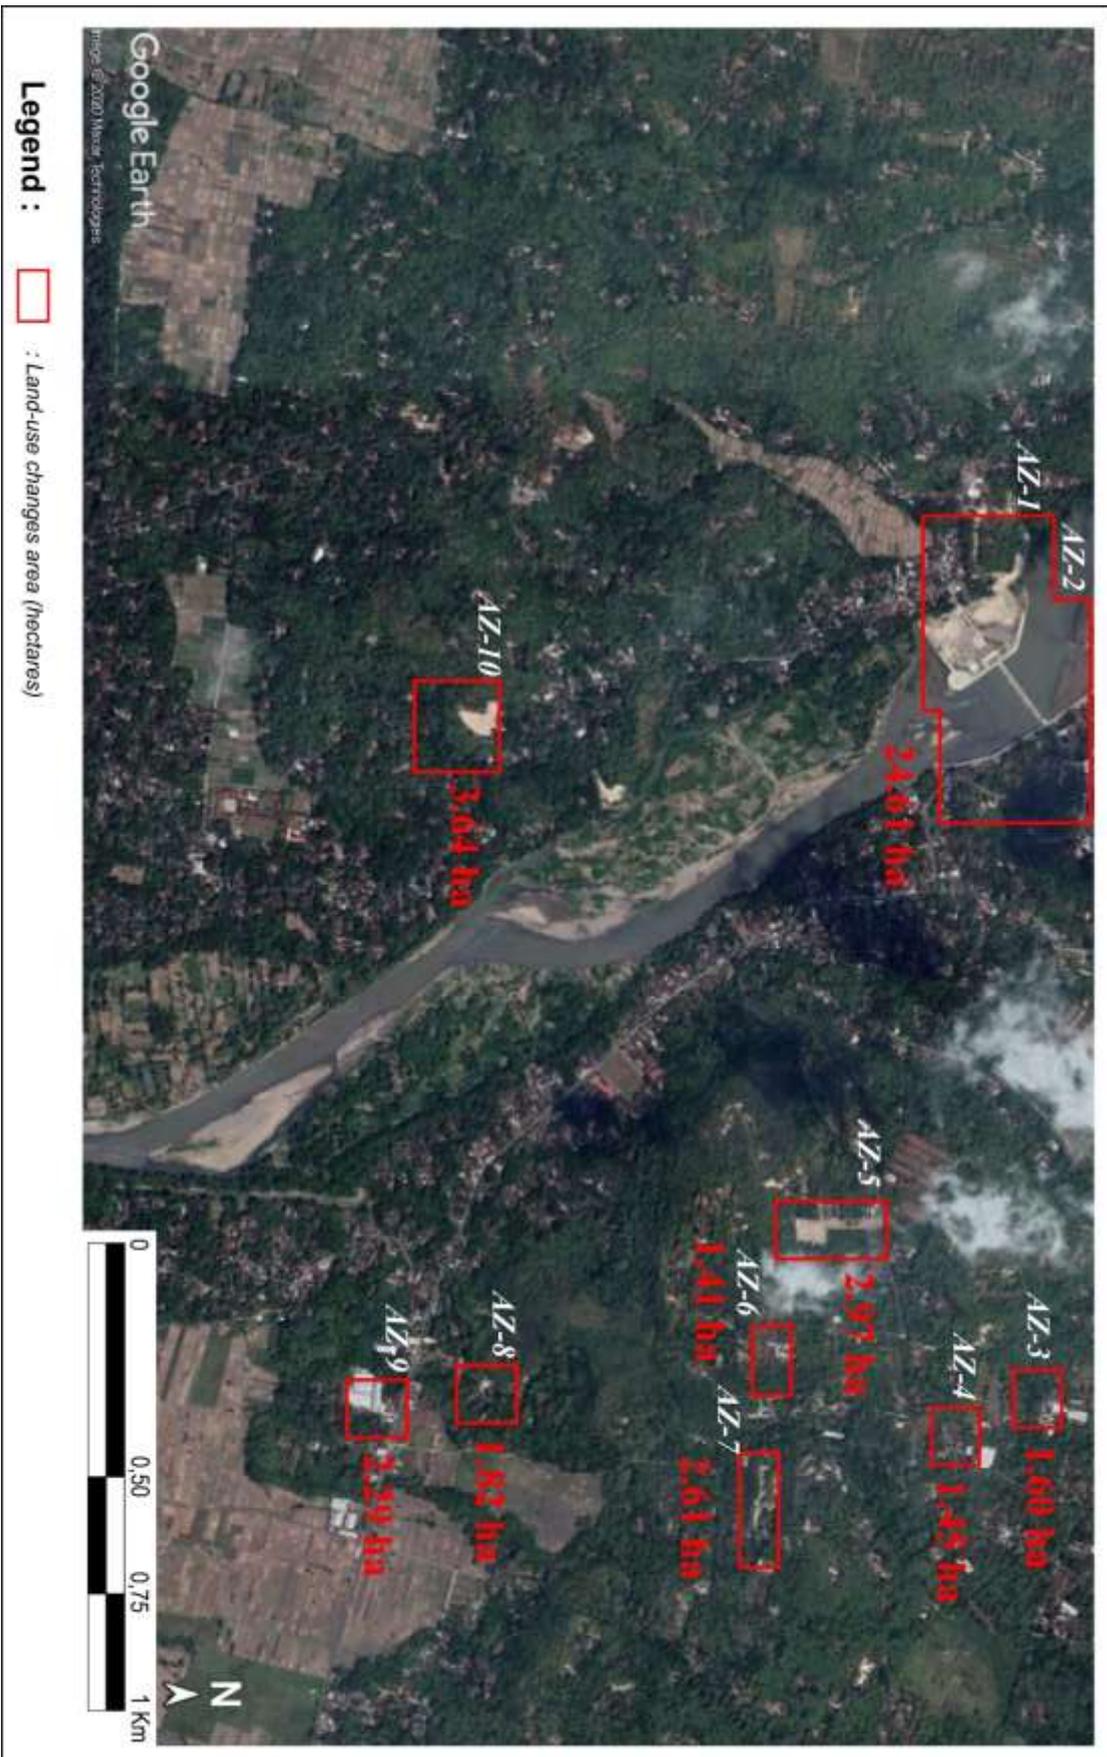
Figure 8. The quantitative calculation on land-use change in the study area.

The authors also attempt to count the quantitative calculation on land-use change in the study area (Figure 8). According to Figure 8, the quantitative calculation on land-use change in the study area from 2012 to 2019 was 42.4 of 1,101.67 hectares the study area total large.

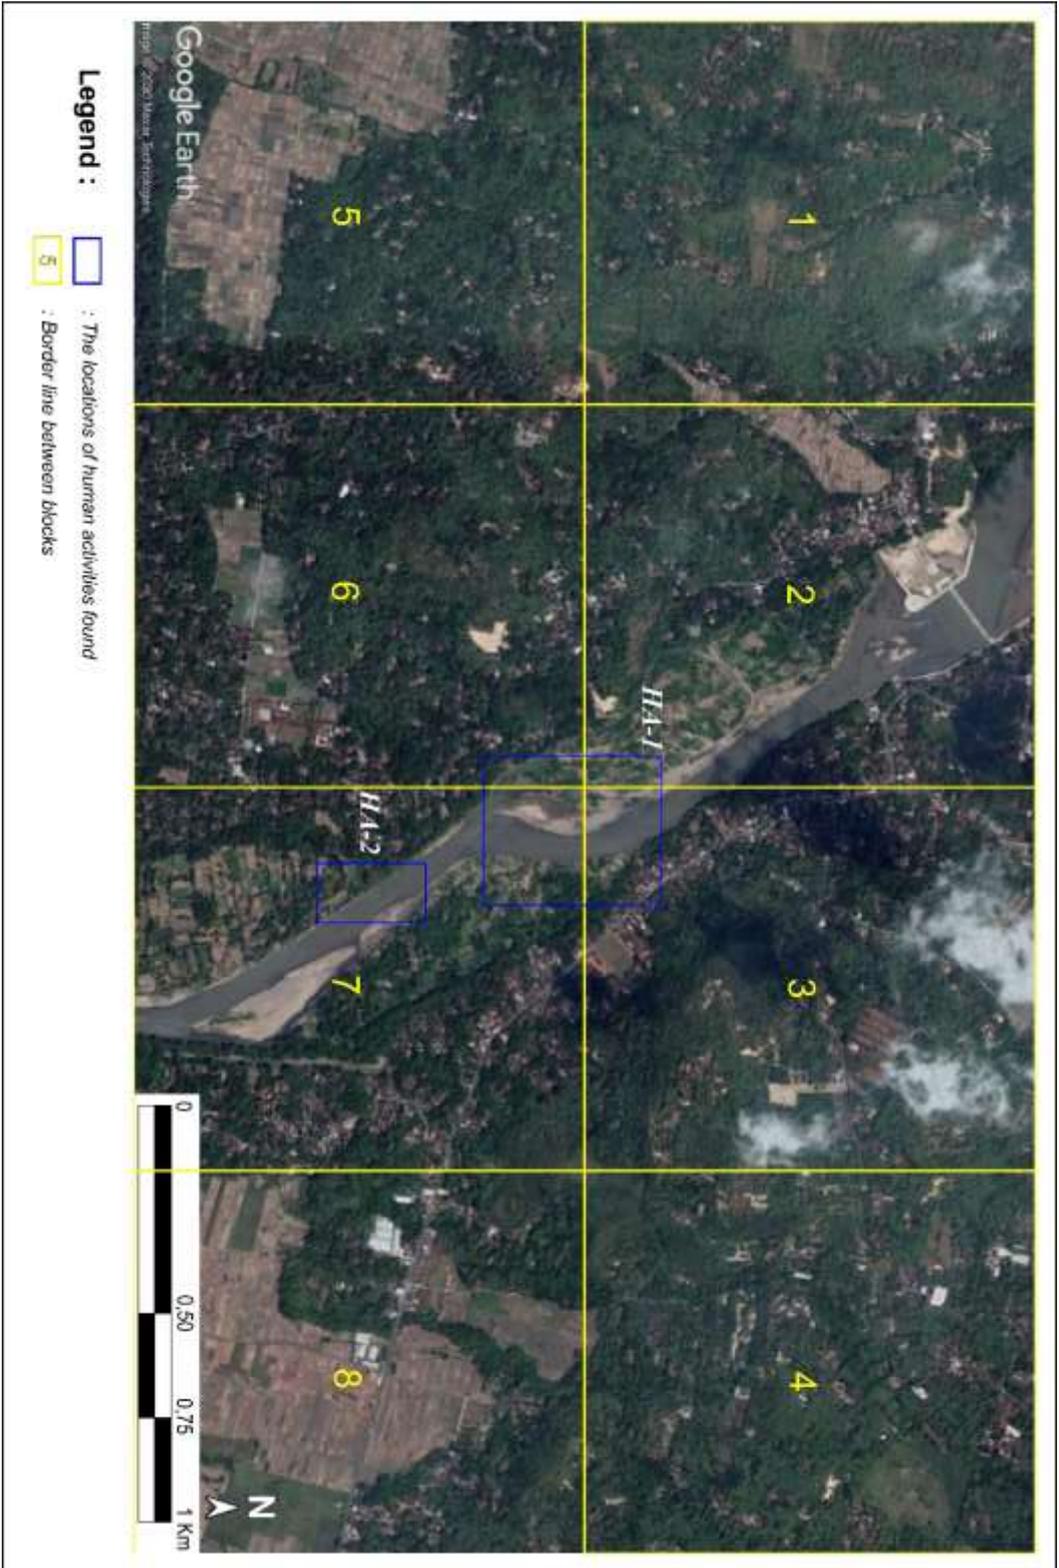
Figure 9. Human activities locations on the Progo River and the surrounding area in 2019 (Google Earth Image).

Figure 9. shows locations on the Google Earth Image that have human activities from 2012 to 2019. Human activities found in the Progo River and its surrounding area include sand mining activities (Figure 11) and garbage disposal in the river (Figure 12). The observation on each block has been created so that the authors have determined two locations with morphological changes due to human activities (Figure 9). Each location was coded HA-1 and HA-2. To clarify each location of human activities that changed the Progo River morphology from 2012 to 2019, it enlarges each blue box (Figure 10).

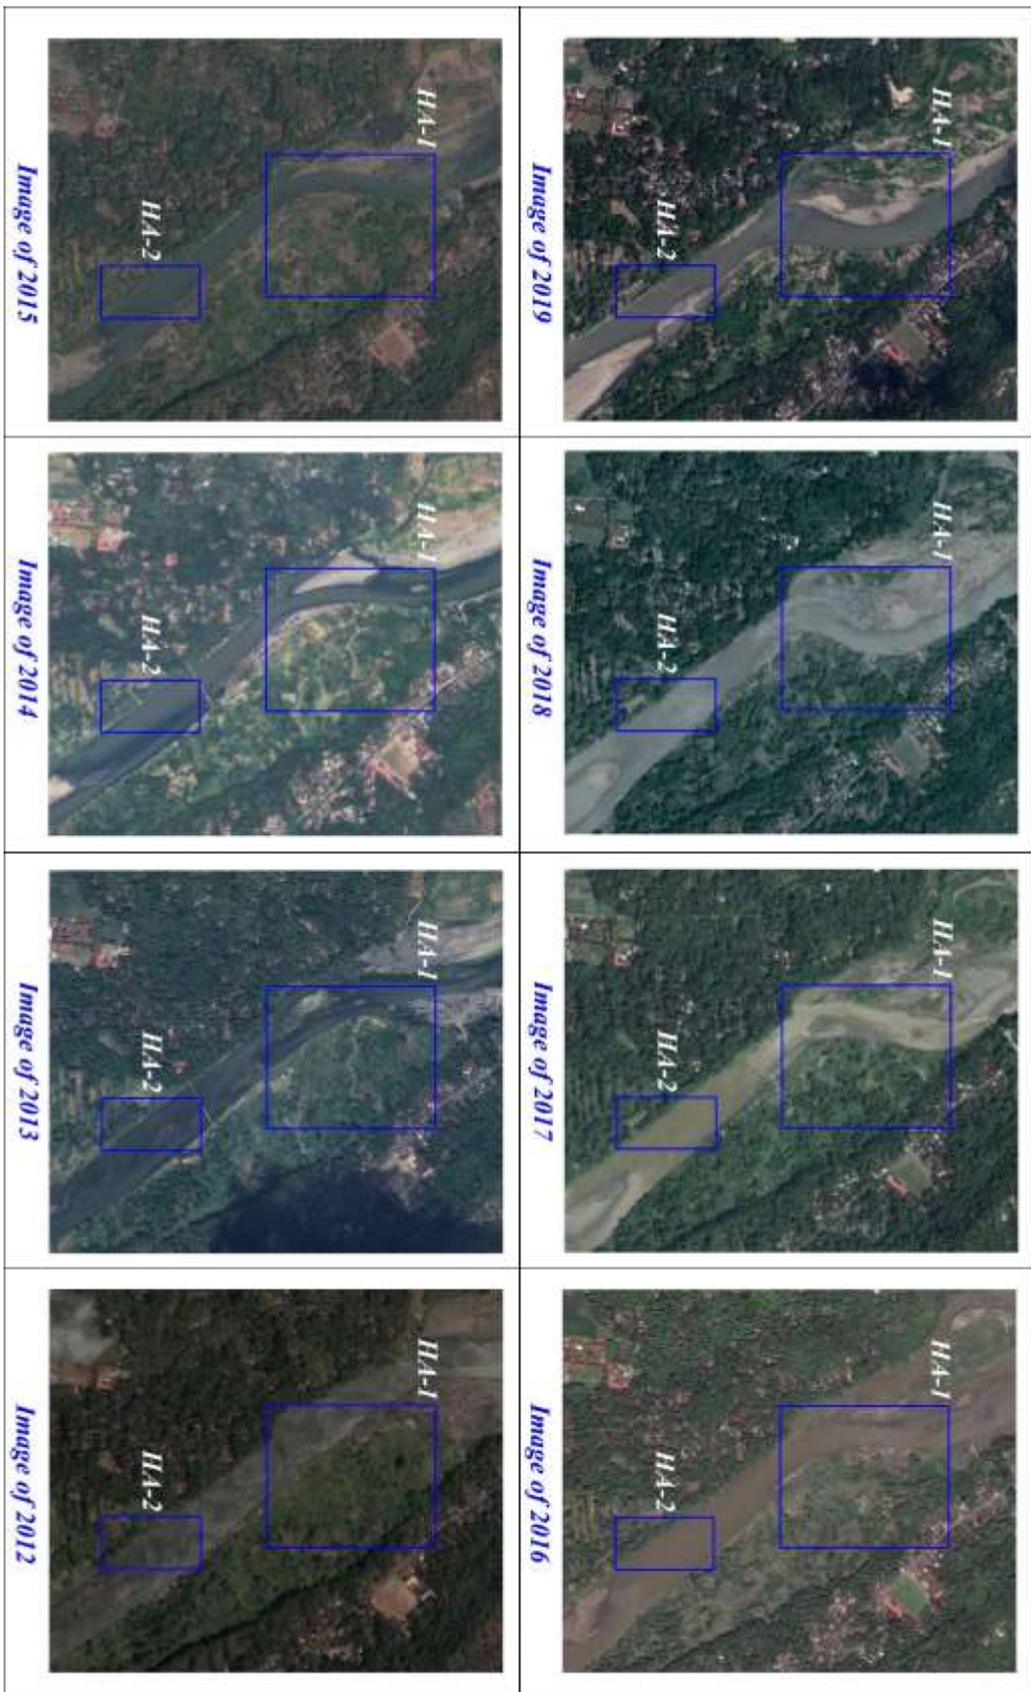
Figure 10. Morphological changes at locations of HA-1 and HA-2 from 2012 to 2019.

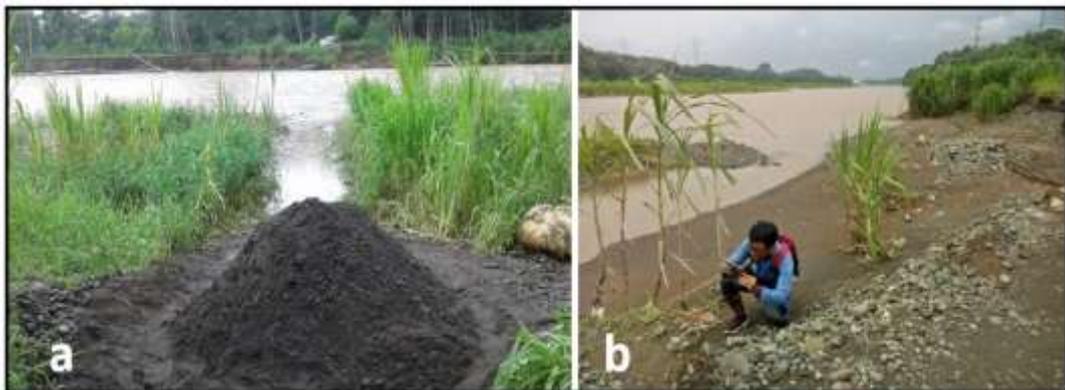
Figure 11. Mining activities along the Progo River. a) Sand mining on the riverbank. b) Location of former sand mining along the Progo River.

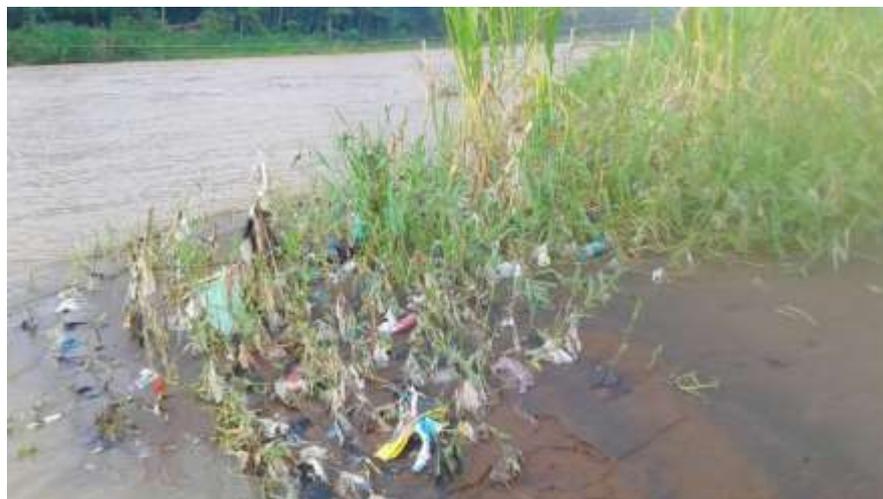
Figure 12. Piles of garbage on the Progo Riverbank.

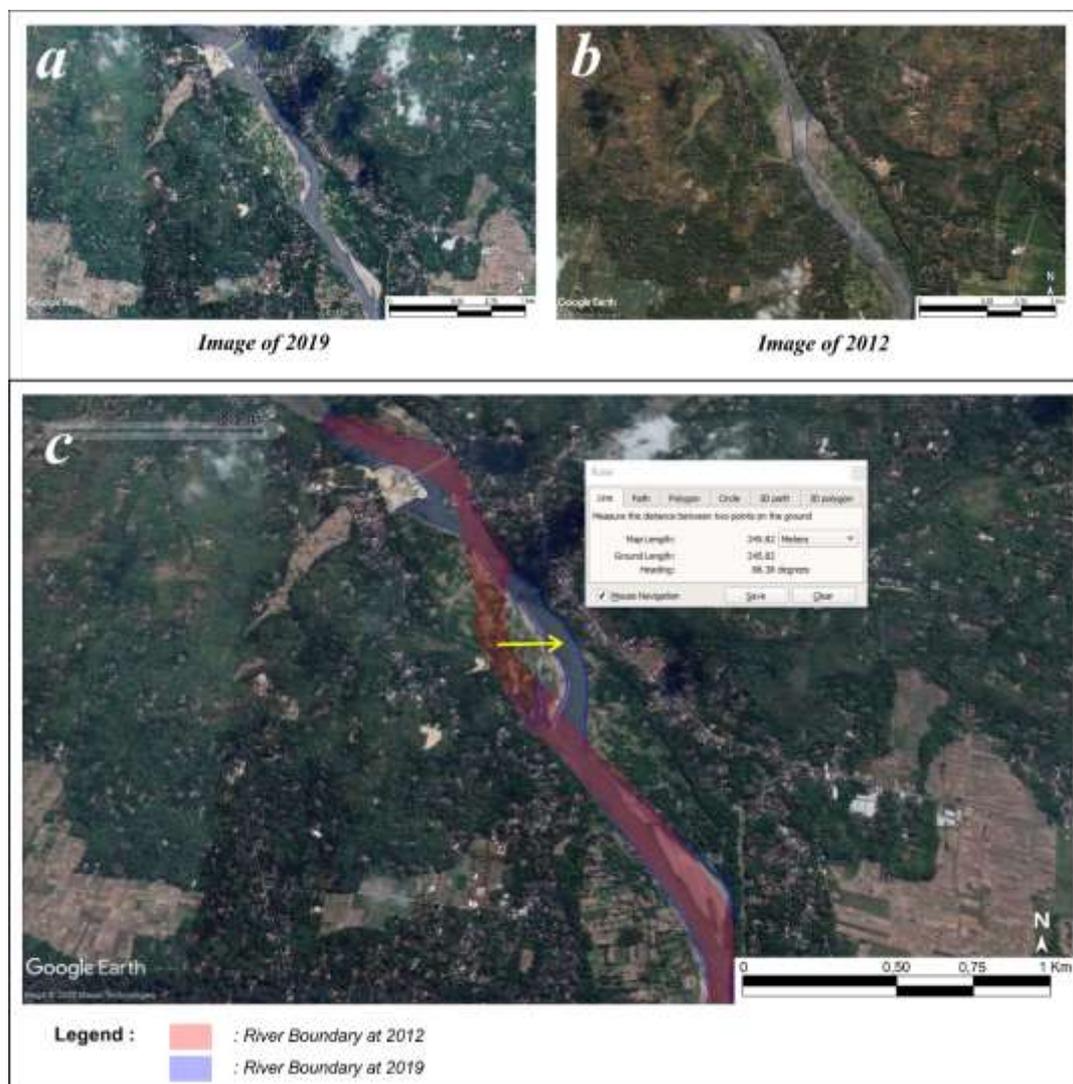
Figure 13. Changes in the direction of river bends which turns more east along 245.82 meters. a) Google Earth Image of 2019. b) Google Earth Image of 2012. c) The direction change of the river.

Anthropogenic factors in the form of land-use changes and human activities have caused morphological changes in the Progo River from 2012 to 2019. It was significant changes (see the yellow arrow) in the river's direction, which turns more east along 245.82 meters (Figure 13). Changes in the direction of river bends were estimated by several anthropogenic factors such as

opening agricultural land, settlement areas, industrial areas, dam construction, mining activities, and piles of garbage. However, the relation between each of these anthropogenic factors and the morphological changes of the Progo River could not be correlated in detail, so further periodical research is needed.
